Putting on the Brakes

Hickam civil engineers undertake the first installation of a new textile brake aircraft arresting system for the Air Force

by Creighton Lee
15th CES

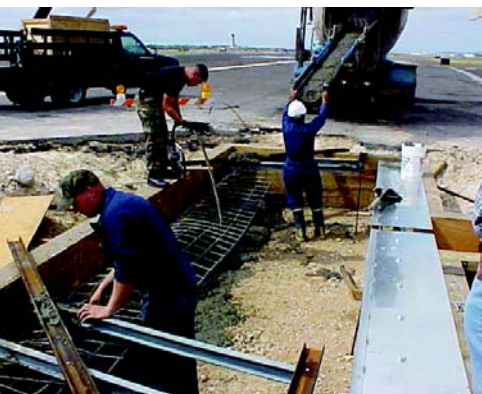
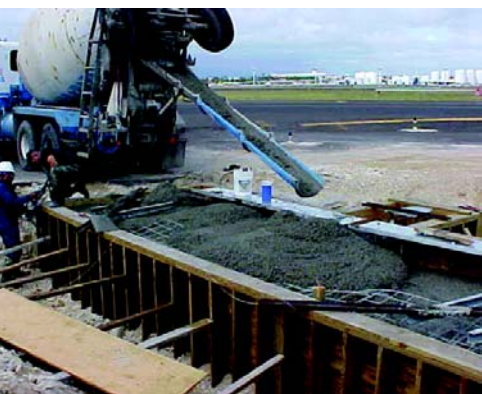
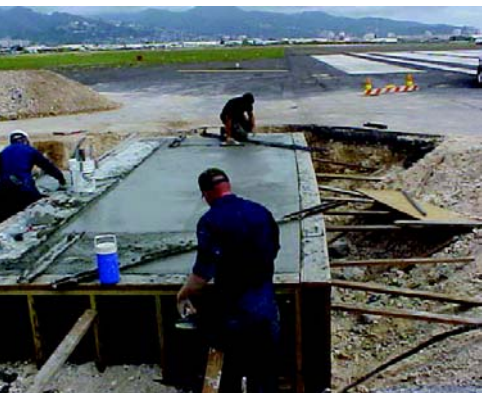
The 15th CES poured about 62 cubic yards of concrete for the textile brake foundation. The installed concrete pad allows for up to 12 module bags on each side of the runway. (Photos courtesy 15th CES)

Compaction was accomplished by completing 4-inch lifts over a period of 16 days for 100 percent density, followed by surveying and preparation for the installation of the forms for the concrete foundations. The team poured 26 cubic yards of concrete for each foundation. A second pair of triangle-shaped forms was poured using about 5 cubic yards of concrete each, totaling 62 cubic yards of concrete for the foundation.

Installation of the textile brake system components was completed in one day. The installation used 100-meter bags, 10 on each side of the runway. The new concrete pad allows for increasing the number of modules to 12 on each side.

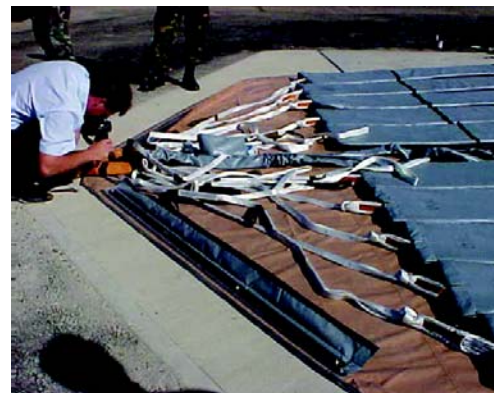
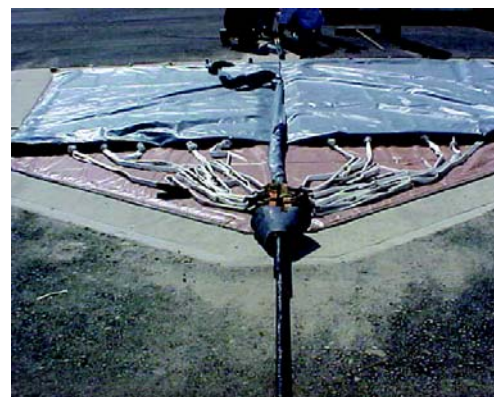
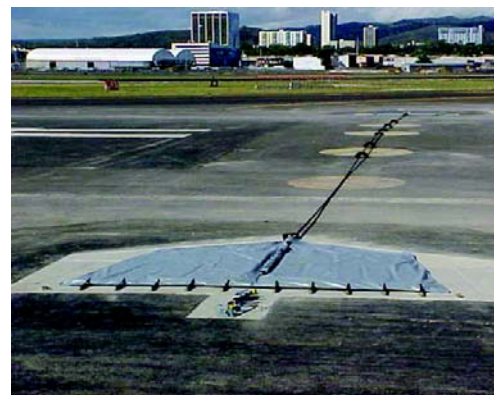
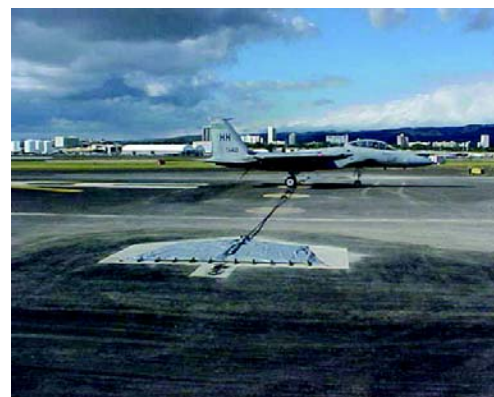
The textile brake uses a tearing strap to absorb the aircraft's kinetic energy during an arrestment. Since the textile brake is designed as a one-time use system, it was installed in a location shown to have a low probability of an actual arrestment.

The textile brake uses a tearing strap to absorb an aircraft's kinetic energy during an arrestment. Two tightly woven nylon straps are sewn together, and it is the longitudinal tearing or shearing of the two straps that provides the braking capability to safely stop the aircraft. It takes 15,000 pounds of force to tear one pair of straps.

The textile brake model (MB 100.10c) used at Hickam is comprised of a set of 10 modules (consisting of the tearing straps) housed in protective environmental covers positioned on each side of the runway. They are connected to a standard 1.25-inch hook cable that is supported every 5 feet by 6-inch rubber donuts. The hook cable is attached to a manually operated winch that allows operators to tension the cable.
